HISTORIC AMERICAN BUILDINGS SURVEY
INVENTORY

2. NAME *Orrin Thompson Mansion*

DATE OR PERIOD *1832*
STYLE *Greek Revival*
ARCHITECT
BUILDER *Orrin Thompson*

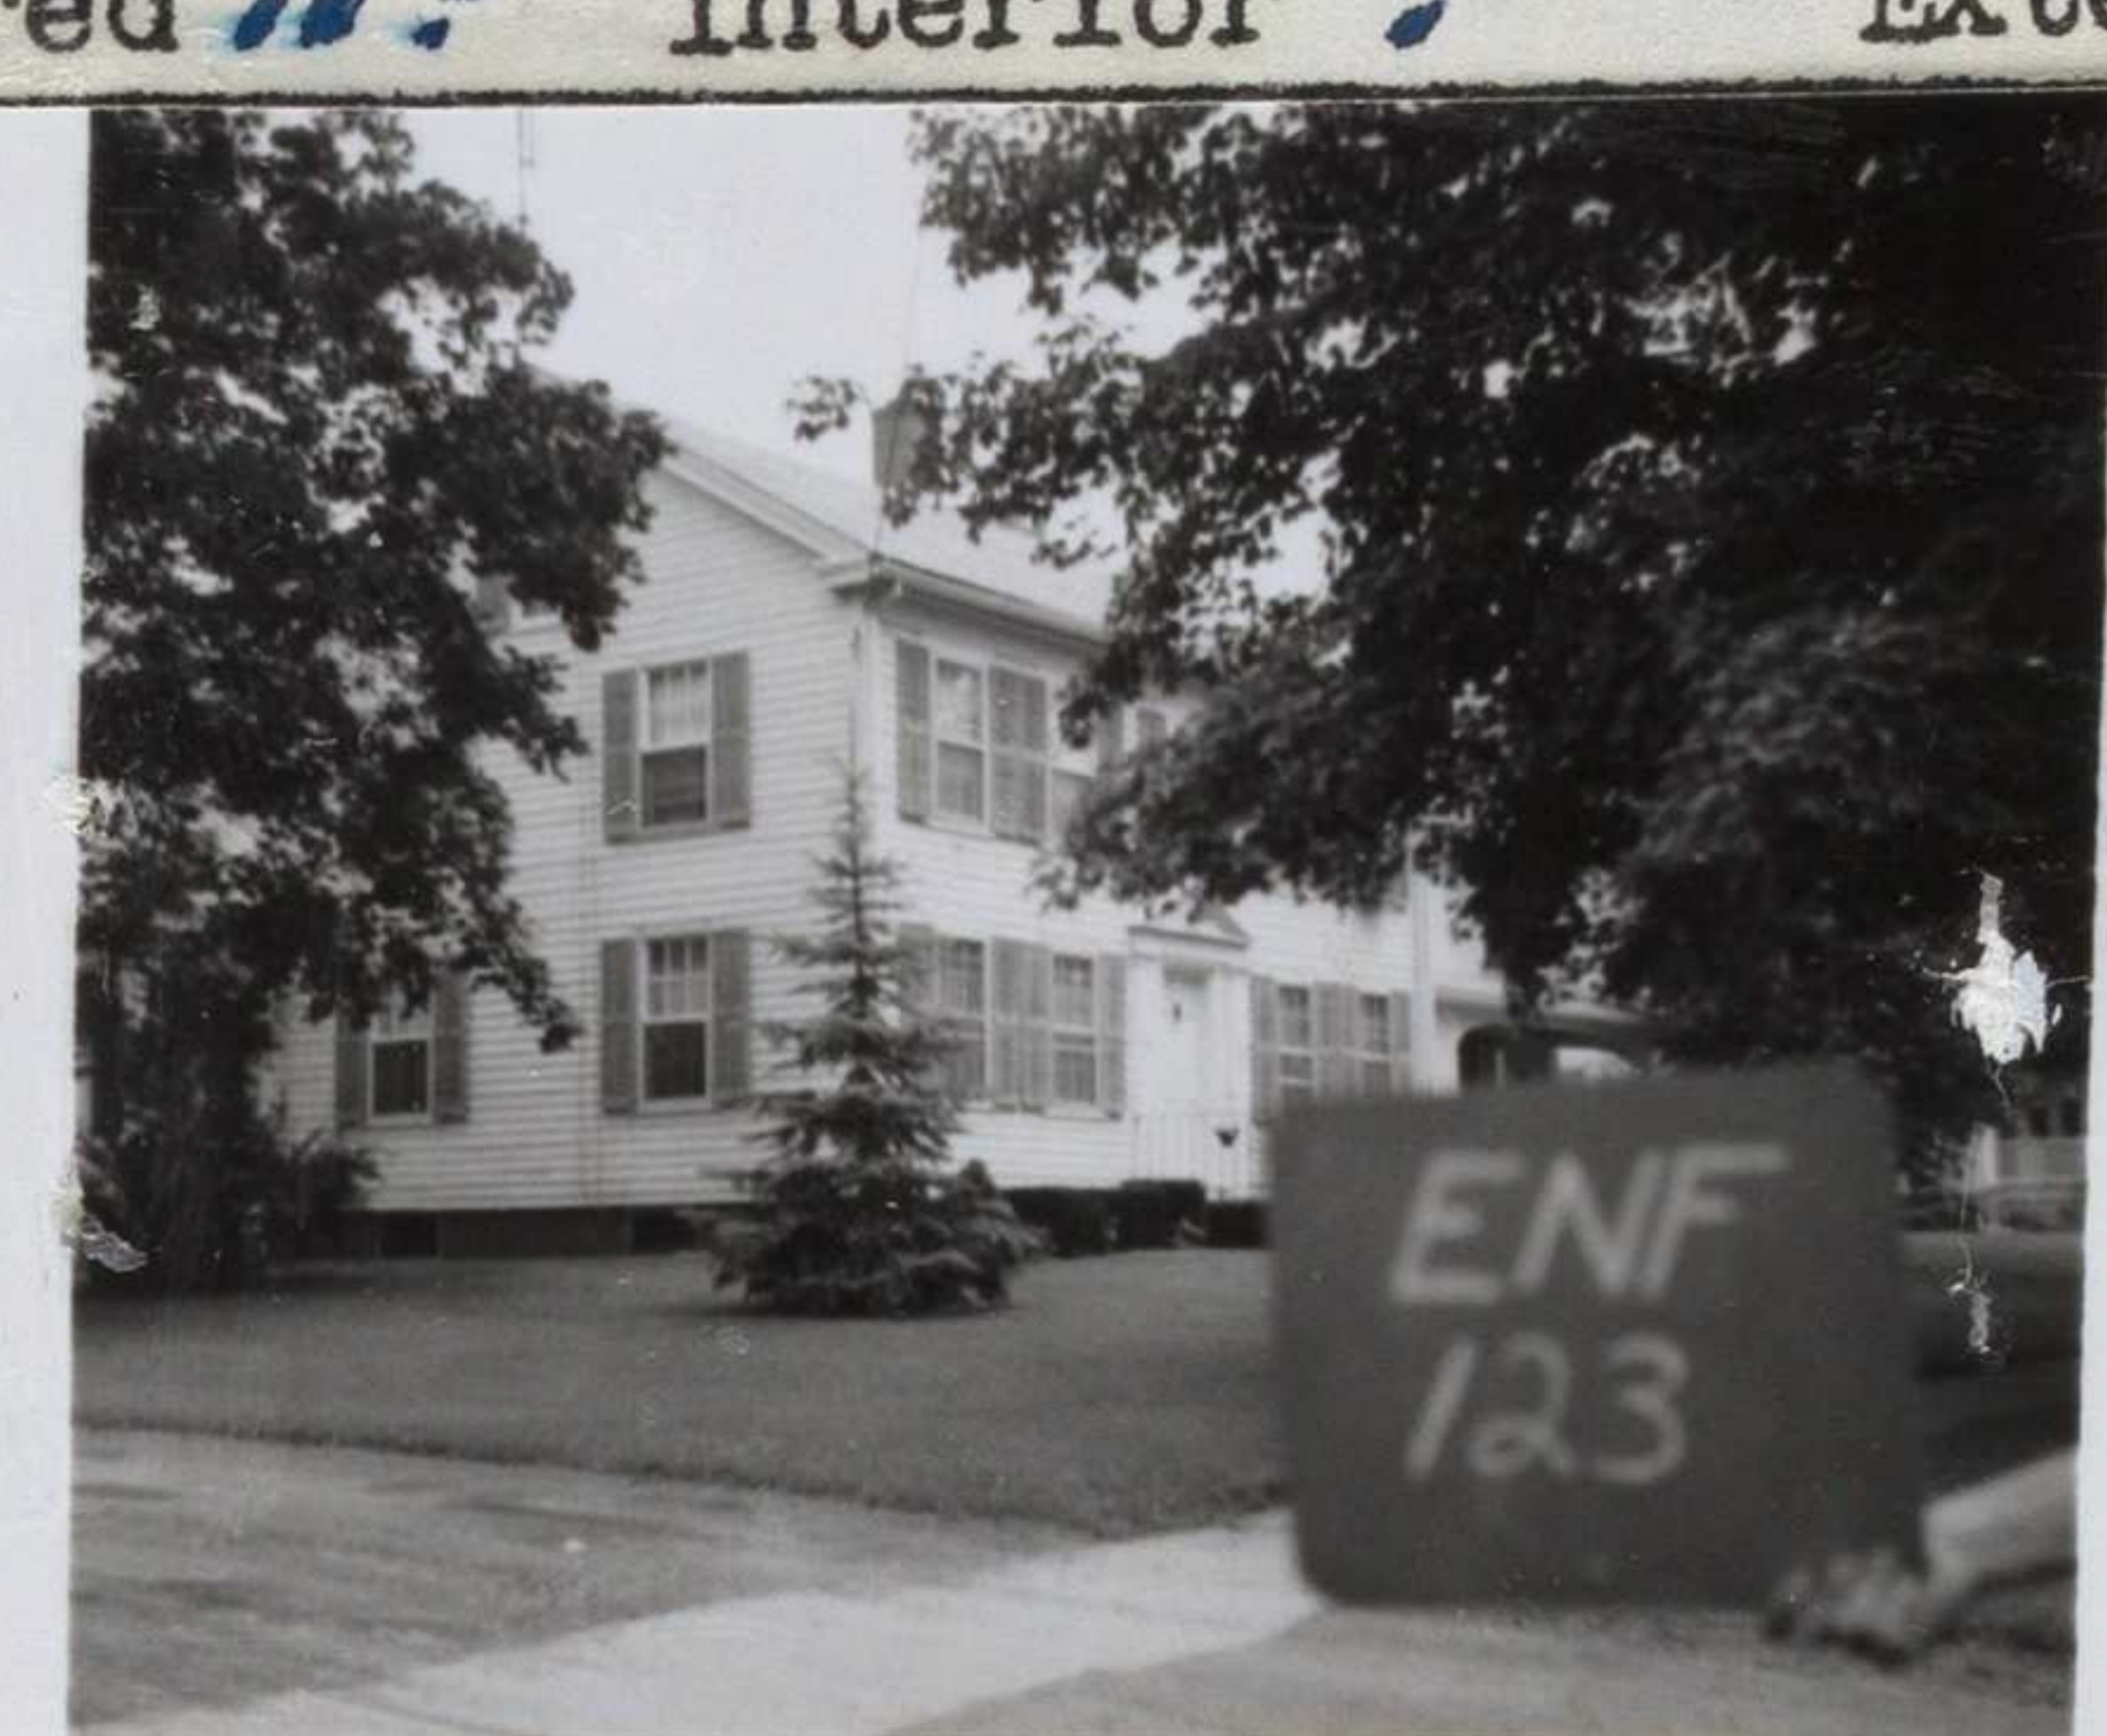
<p>7. PHOTOGRAPH <i>Enf 123</i></p>

<p>1. STATE <i>CT</i> COUNTY <i>Hartford</i> TOWN <i>Enfield</i> VICINITY STREET NO. <i>105 Main St. (H3rdvl)</i> ORIGINAL OWNER <i>?</i> ORIGINAL USE <i>Residence</i> PRESENT OWNER <i>?</i> PRESENT USE <i>Residence</i> WALL CONSTRUCTION <i>clapboard</i> NO. OF STORIES <i>2</i></p>		<p>HISTORIC AMERICAN BUILDINGS SURVEY INVENTORY</p> <p>2. NAME DATE OR PERIOD <i>1800</i> STYLE <i>federal</i> ARCHITECT BUILDER</p> <p>3. FOR LIBRARY OF CONGRESS USE</p>	
<p>4. NOTABLE FEATURES, HISTORICAL SIGNIFICANCE AND DESCRIPTION</p> <p><i>This five bay house has a brick founda- tions and shallow pitched roof, punctuated with a central chimney. The shuttered windows are 6/6 with simple moldings. The ^{door} way is new as are the wings to the rear and East.</i></p>		<p>OPEN TO PUBLIC <i>No</i></p>	
<p>5. PHYSICAL CONDITION OF STRUCTURE</p>		<p>Endangered <i>No</i> Interior <i>?</i> Exterior <i>good</i></p>

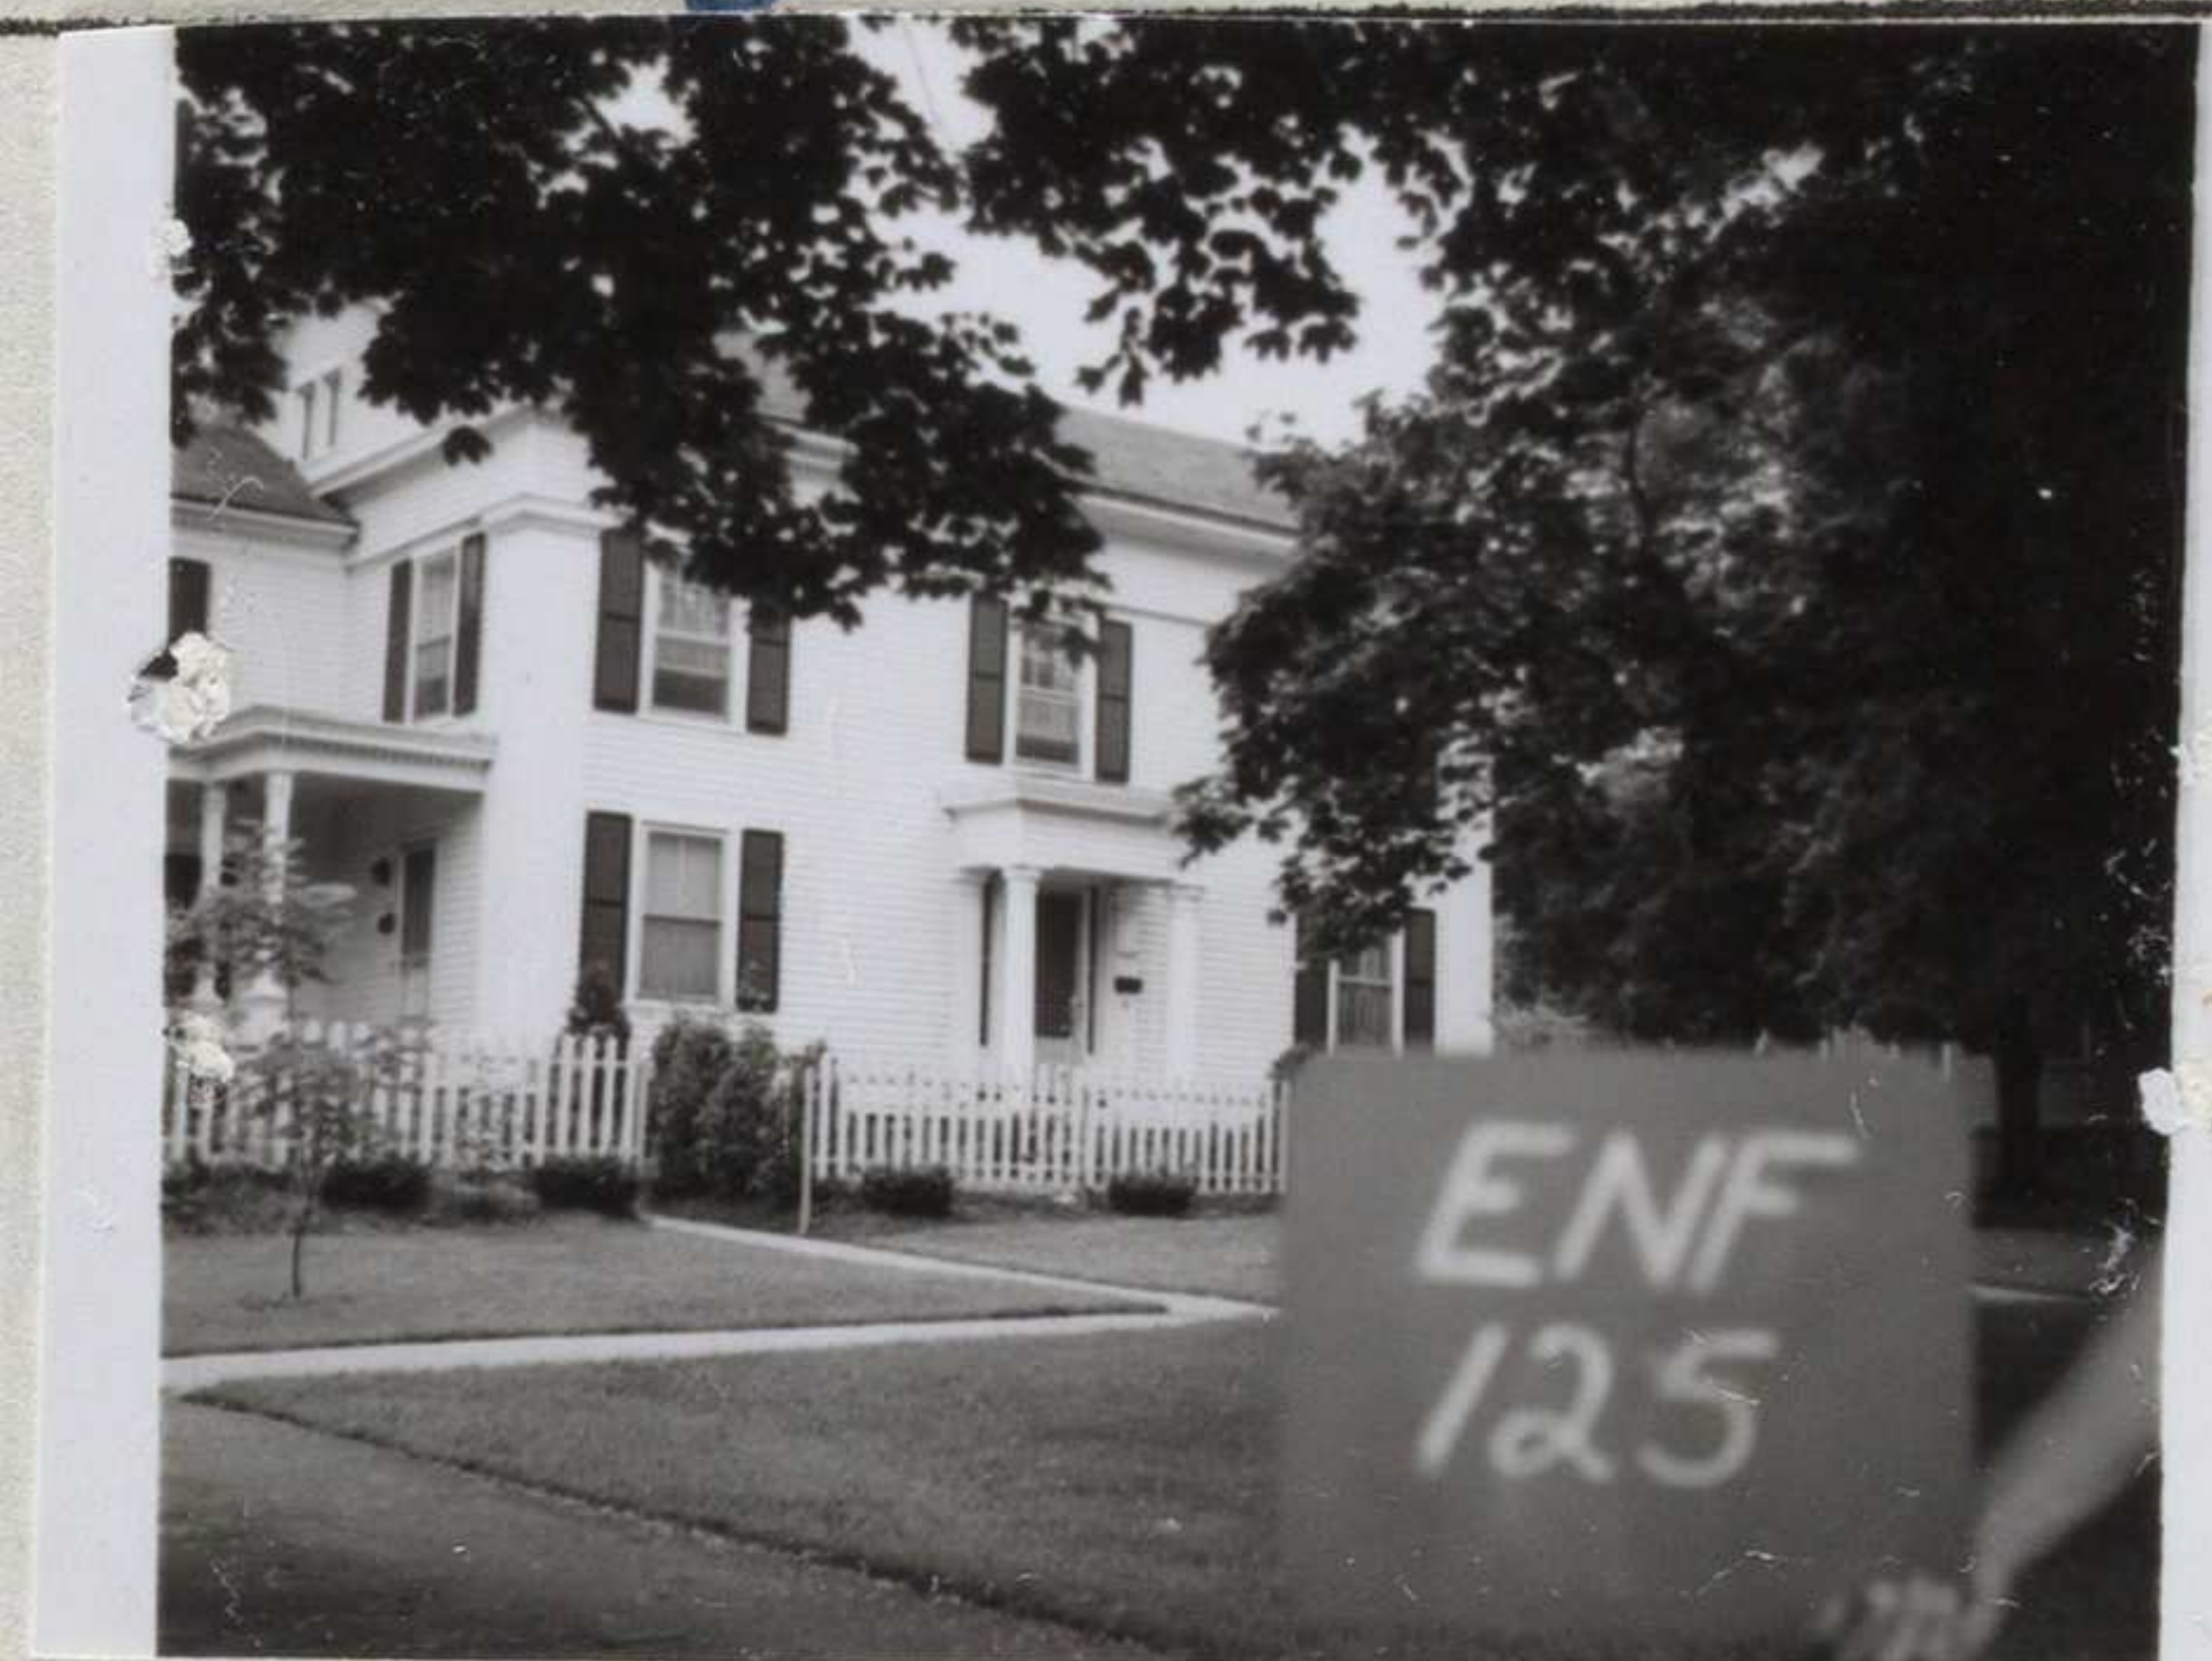
7. PHOTOGRAPH *Enf 125*

There are three bays to this house where there may well have been five. Built on a brown-stone foundation, the place has a shallow pitched roof. The windows are 6/6, the door with transom and sidelights is framed in a portico with Roman Doric pilasters and columns. The pilasters are echoed at the house's corners, supporting a heavily dentilled entablature.

5. PHYSICAL CONDITION OF STRUCTURE

Endangered *No* Interior *fair* Exterior *fair*

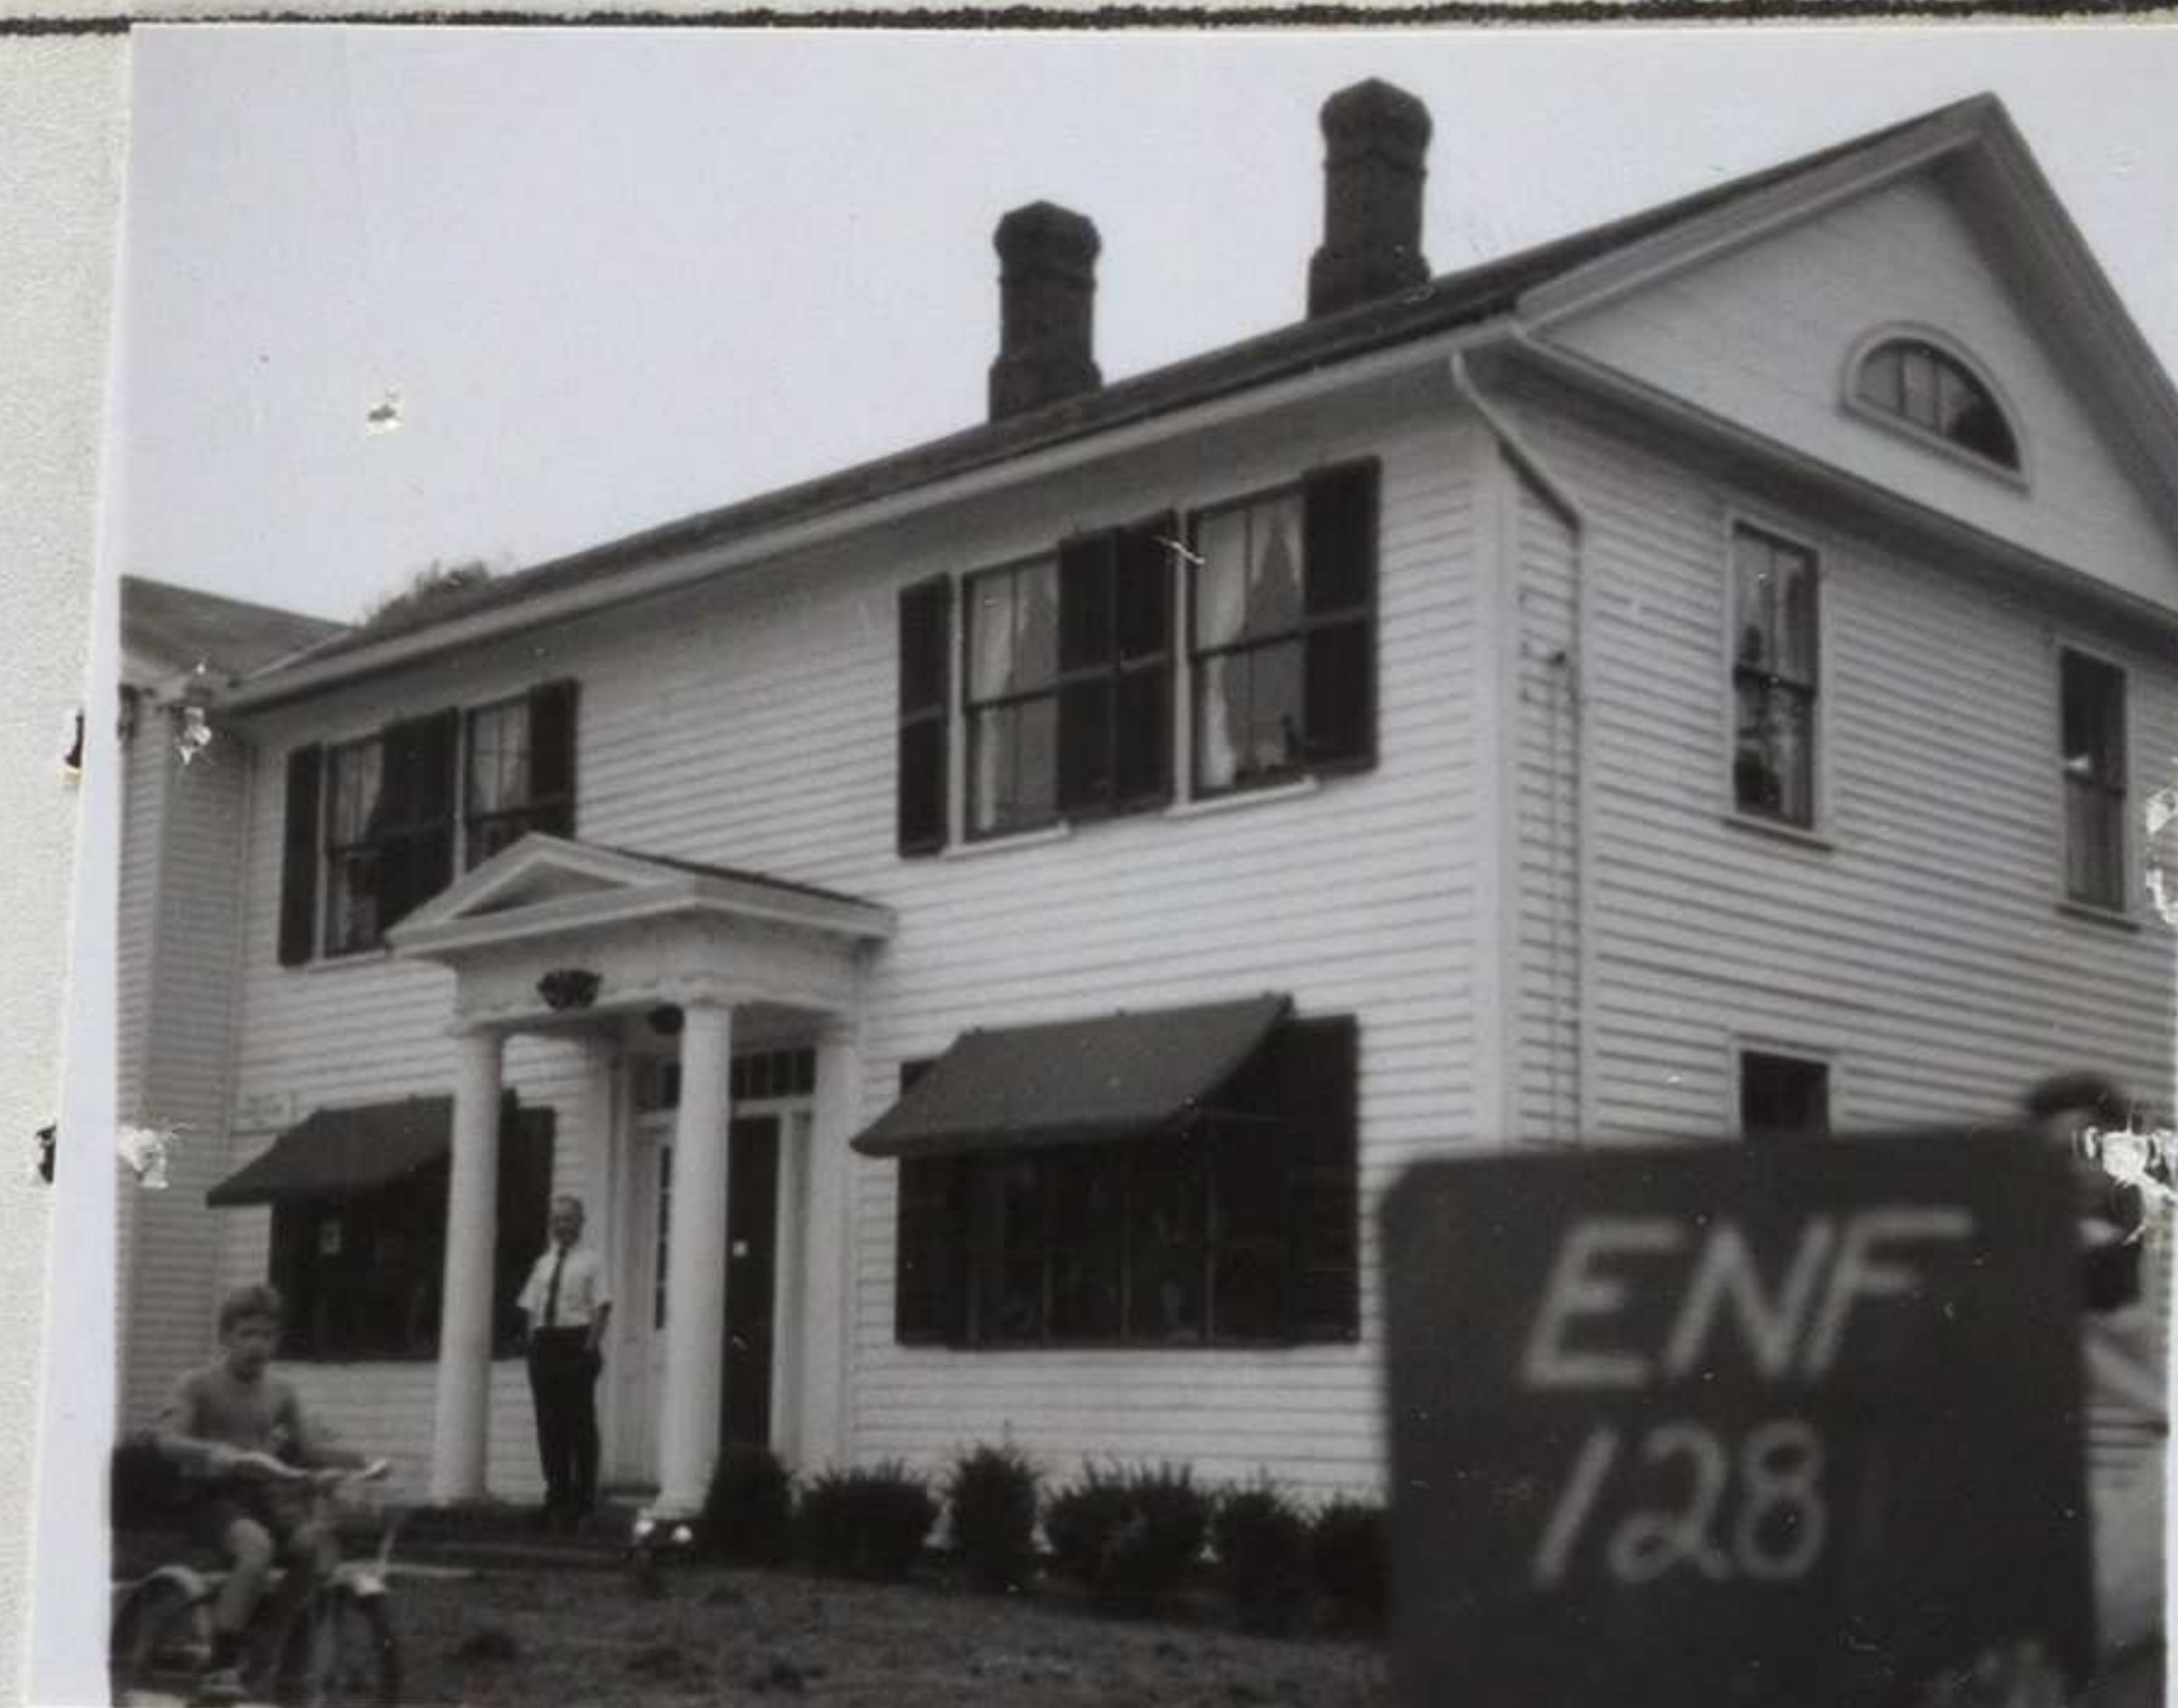
7. PHOTOGRAPH *ENF 128*8. PUBLISHED SOURCES (Author, Title, Pages)
INTERVIEWS, RECORDS, PHOTOS, ETC.9. NAME, ADDRESS AND TITLE OF
RECORDER

This fine old house has recently become the hub of a furniture store. Sad! It is built on a brownstone foundation, with five bays with non original windows. The medium pitched roof has double central chimneys, and forms a plain boarded pediment with semicircular window. The 6 paneled door is surrounded by an outstanding portico and doorway. There are both transom (8 panes) and sidelights (4 panes each) atop panels. Fluted pilasters and plain doric columns support an entablature complete with triglyphs and guttae.

Endangered ? Interior *Poor?* Exterior *fair*

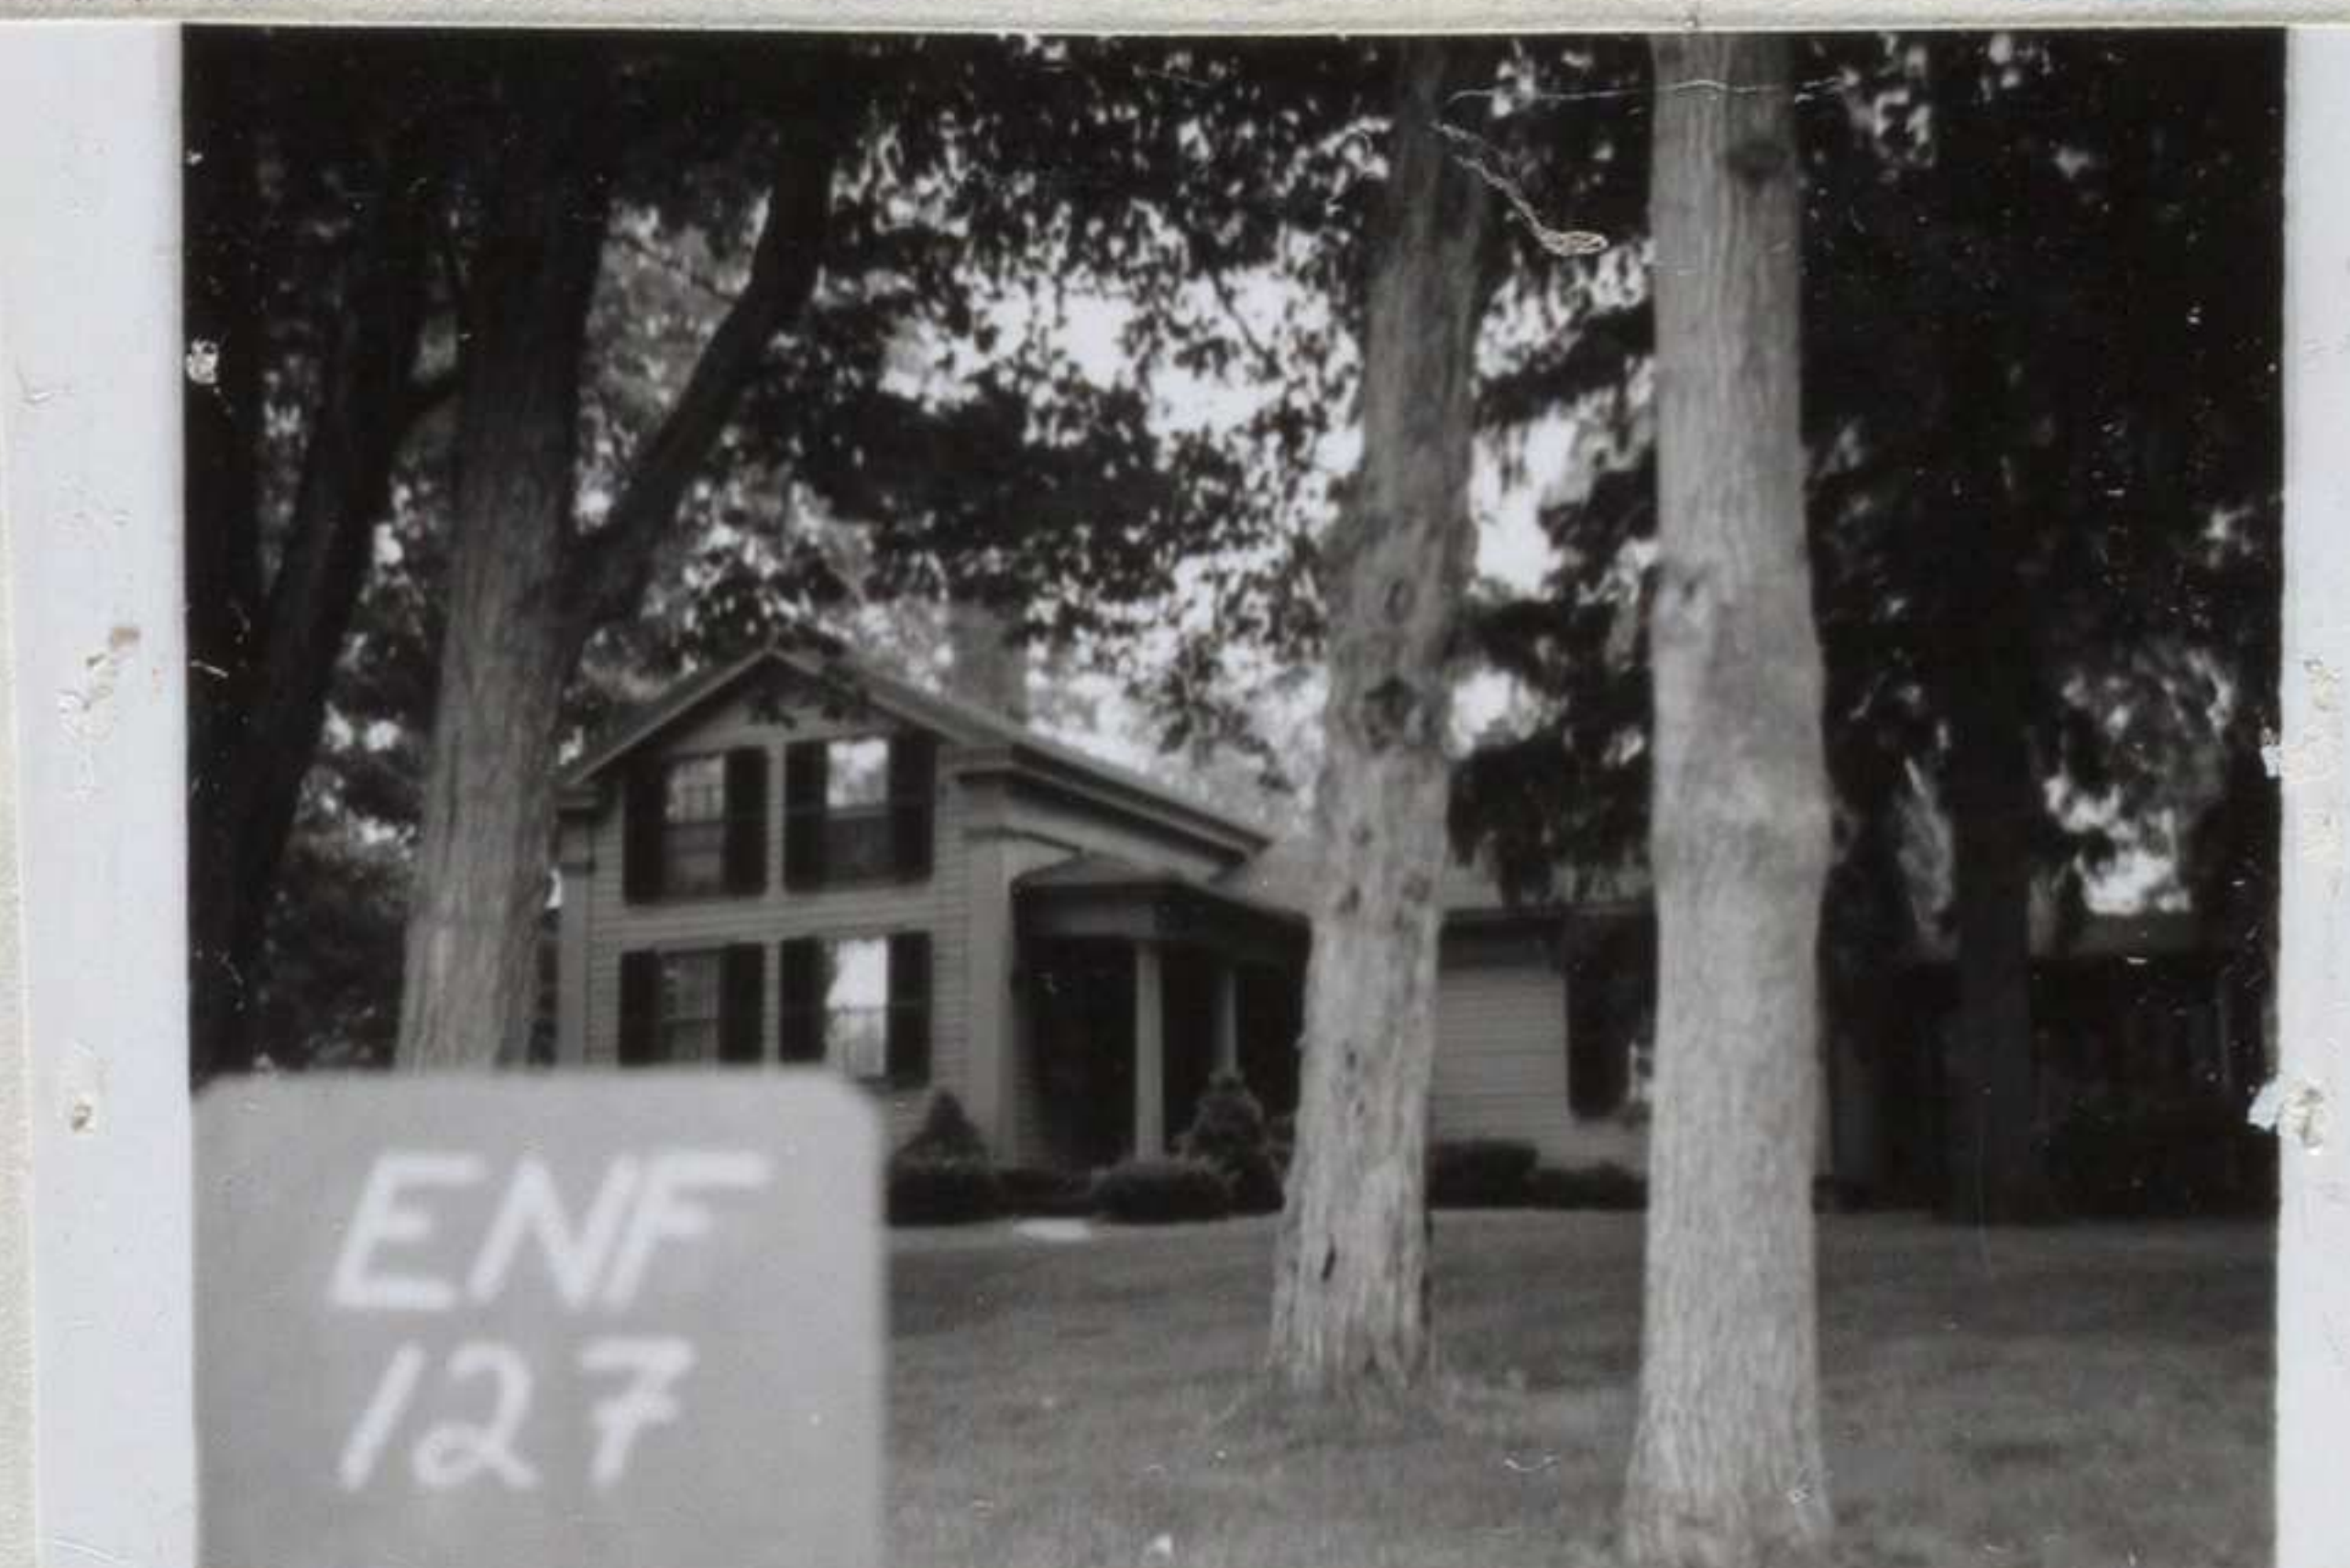
<p>7. PHOTOGRAPH <i>Enf 127</i></p>

<p>1. STATE <i>ct</i> COUNTY TOWN <i>Enfield</i> VICINITY STREET NO. <i>139 Enfield Street</i></p> <p>ORIGINAL OWNER? ORIGINAL USE <i>Residence</i> PRESENT OWNER? PRESENT USE <i>Residence</i> WALL CONSTRUCTION <i>clapboard</i> NO. OF STORIES <i>1 1/2</i></p>		<p>HISTORIC AMERICAN BUILDINGS SURVEY INVENTORY</p> <p>2. NAME</p> <p>DATE OR PERIOD <i>1840</i> STYLE <i>Greek Revival</i> ARCHITECT BUILDER</p> <p>3. FOR LIBRARY OF CONGRESS USE</p>	
<p>4. NOTABLE FEATURES, HISTORICAL SIGNIFICANCE AND DESCRIPTION</p> <p><i>Set on an L shaped foundation this is an L shaped house, the south arm being of but one story. The shallow pitched roof is supported on plain doric pilasters. The windows are all 6/6. To the south of the main arm is porch with greek doric columns without plinth blocks. It is very, very simular to the Christopher Parsons house.</i></p>			<p>OPEN TO PUBLIC <i>No.</i></p>
<p>5. PHYSICAL CONDITION OF STRUCTURE</p>		<p>Endangered <i>No.</i> Interior <i>fair?</i> Exterior <i>good</i></p>

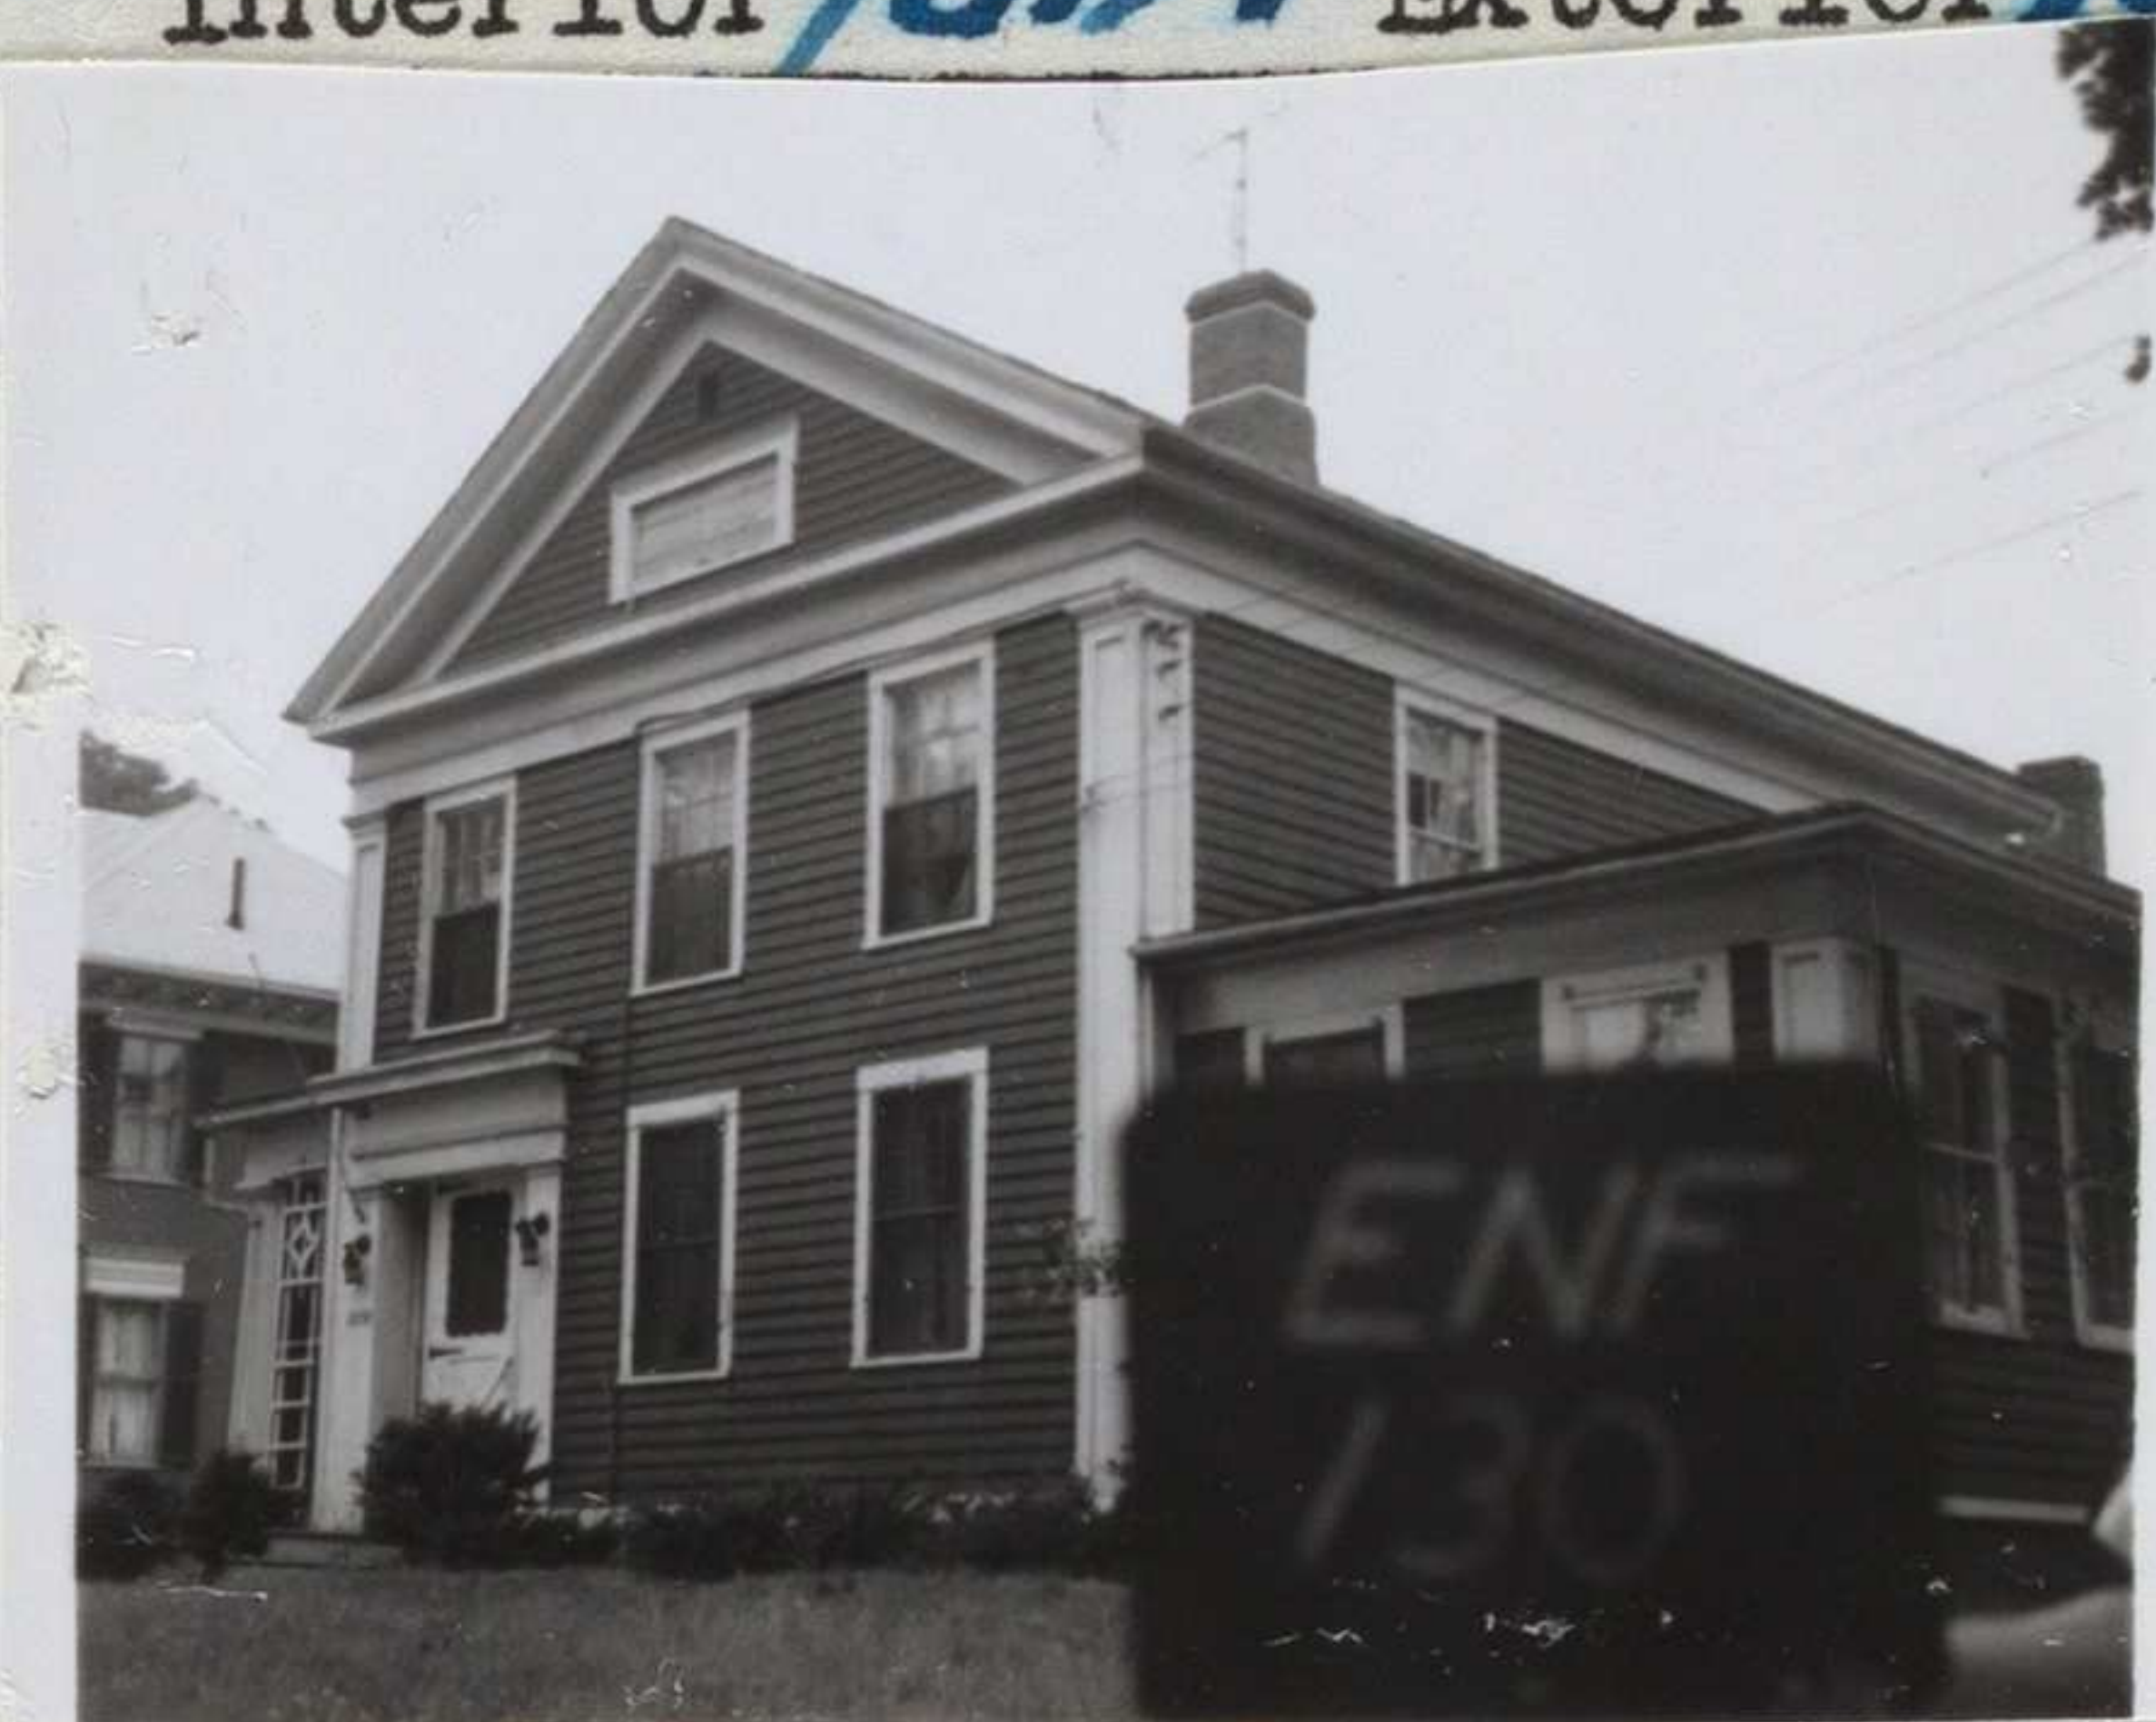
</p> <p>7. PHOTOGRAPH <i>Enf 130</i></p>

<p>1. STATE <i>ct</i> COUNTY TOWN <i>Enfield</i> VICINITY STREET NO. <i>1070 Enfield Street.</i></p> <p>ORIGINAL OWNER? ORIGINAL USE <i>Residence</i> PRESENT OWNER? PRESENT USE <i>Residence</i> WALL CONSTRUCTION <i>clapboard</i> NO. OF STORIES <i>2</i></p>		<p>HISTORIC AMERICAN BUILDINGS SURVEY INVENTORY</p> <p>2. NAME</p> <p>DATE OR PERIOD <i>1830</i> STYLE <i>Greek Revival</i> ARCHITECT BUILDER</p> <p>3. FOR LIBRARY OF CONGRESS USE</p>	
<p>4. NOTABLE FEATURES, HISTORICAL SIGNIFICANCE AND DESCRIPTION</p> <p><i>This three bay house is built on a brick foundation and ^{has} a shallow pitched roof. There is a rectangular pedimental window in the front pediment. The other windows are 6/6 and the doorway has long side-lights. There are plain paneled pilasters and entablature.</i></p> <p>

<i>ped. window</i></p>		<p>OPEN TO PUBLIC <i>No</i></p>	
<p>5. PHYSICAL CONDITION OF STRUCTURE</p> <p><i>Endangered No Interior fair? Exterior fair</i></p> <p>
